Coal City – Braidwood Tornado of June 22, 2015 and the Impact on the Braidwood Nuclear Generating Station Meteorological Monitoring System

By Mark T. Carroll, Steven G. Mirsky, Heather A. Cramond and Andrew J. Lotz, Murray and Trettel, Inc.

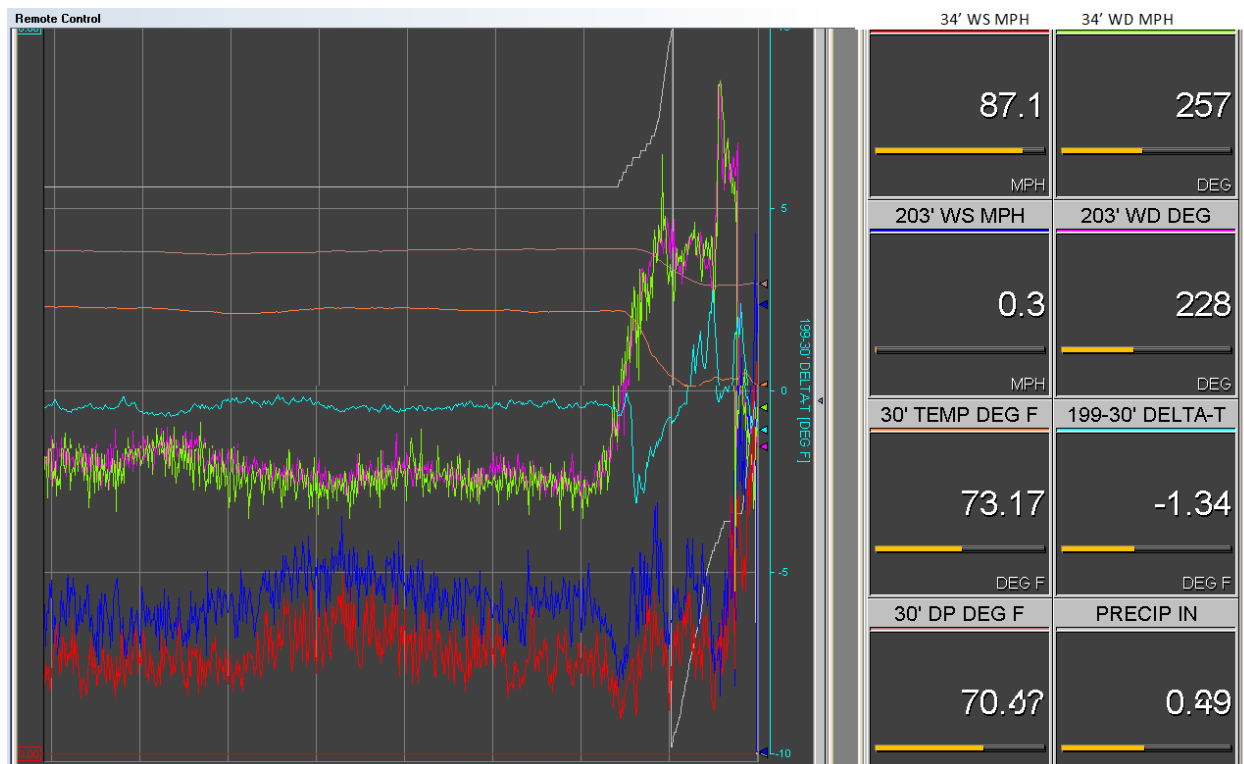
The 203' wind speed sensor failed by 20:59:40. The 34' wind speed sensor failed by 21:00:30.

The above snapshot of the Yokogawa digital recorder which resides in the instrument shelter adjacent to the meteorological monitoring tower at Braidwood, shows the 34' wind speed sensor reading 87.1 mile per hour. The digital recorder takes 10 second data samples. The 203' wind speed sensor had failed by the time the above snapshot had been take, evidenced by a wind speed value of 0.3 mph. The timestamp of the above snapshot was 20:59:20 CST (21:59:20 CDT).

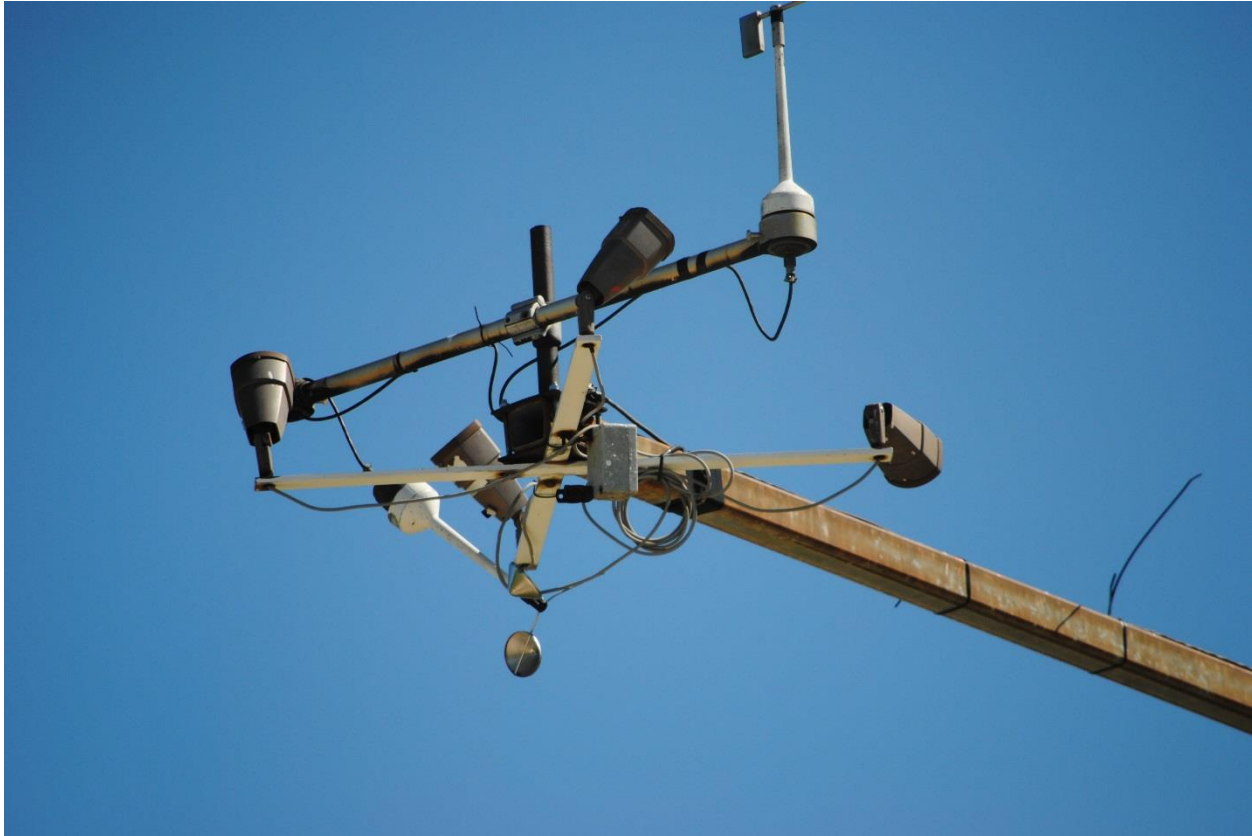
34' wind measurement system. Wind speed sensor is hanging upside down and cups are caught in the cable. Wind direction sensor is intact but not providing valid data.

Murray and Trettel field staff arrived at Braidwood early on June 23. The field service personnel however were initially not able to drive to the meteorological monitoring tower due to downed wires and trees. Later that morning, Braidwood staff was able to provide Murray and Trettel personnel with access to the tower. By noon on the day following the tornado, the 34' wind speed, 34' wind direction and 203' wind speed had been repaired and were sending valid data to the Braidwood Station Control Room. The 203' wind speed sensor had been completely removed from the tower (the sensor was never found). The wind direction cable was also ripped from the tower during the tornado passage. A new wind speed signal cable had to be built in Murray and Trettel's shop. The field technicians returned the next morning (6/24/15) with the new wind speed signal cable and a calibrated wind speed sensor. The 203' wind speed sensor was back in service by 10 a.m. CST on June 24.

Prompt response by Murray and Trettel field services personnel limited system down time. Both wind direction sensors and the lower level wind speed sensor were restored to operational status within 14 hours of the tornado. The 203' wind speed sensor was restored to operational status within 37 hours of the damaging tornado (a new wind speed cable had to be made by a technician to replace the cable lost during the tornado).

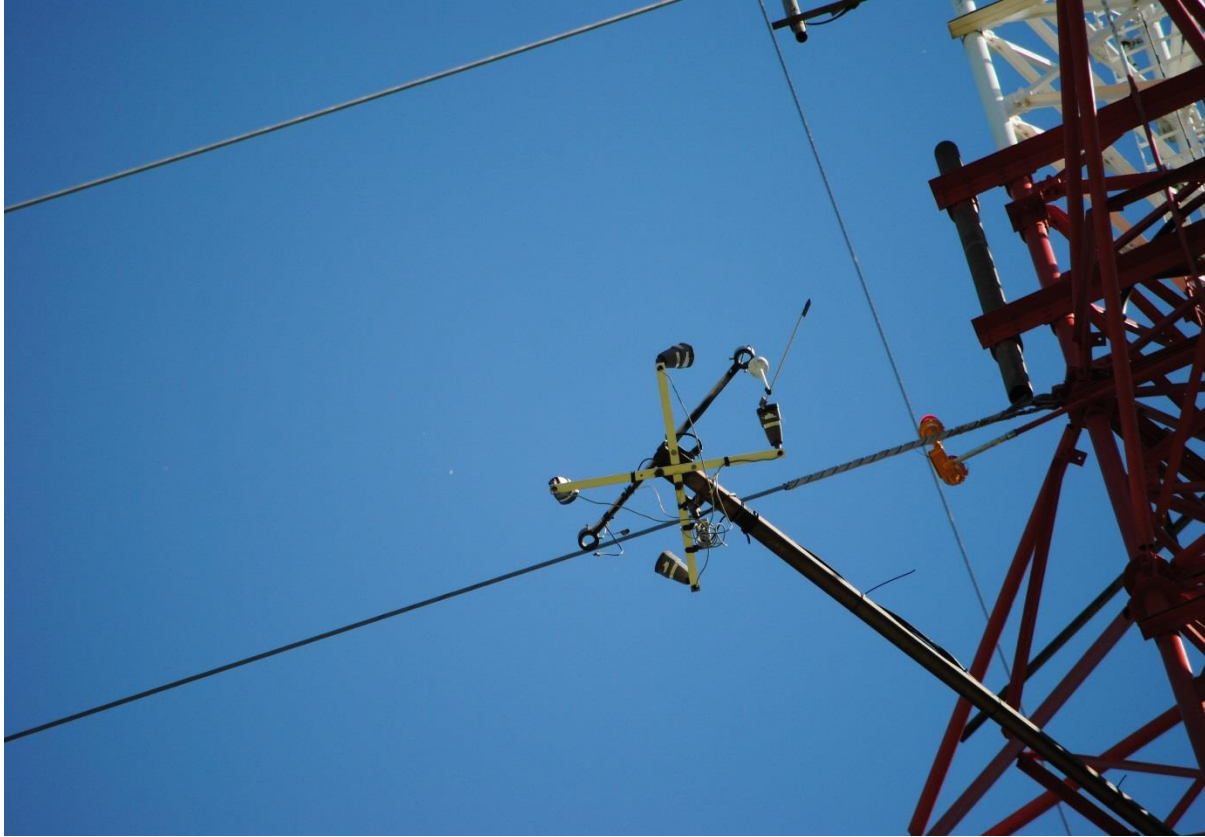
203' wind measurement system. Wind speed sensor is missing. Wind direction sensor is hanging upside down.
